Property Inspection Report

Apartment Building - San Jose, CA 95128

Report Number:
I0630306-315

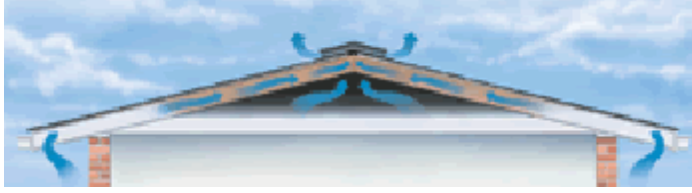
- **Repair:** The soffit vents should be properly screened to prevent insect and vermin entry. The damaged soffit vent screens at the front of the properly should be replaced.
- **Repair:** The level of ventilation throughout the attic cavity should be improved. It is generally required that one square foot of free vent area be provided for every one hundred and fifty square feet of ceiling area. Proper ventilation will help to keep the home and garage cooler during warm weather and extend the life of the roofing materials. Proper ventilation will also help reduce the potential for heat build-up and condensation within the attic.
